## Centrifuge Incident (2007)

Hazard Alert No. 45 (2007)

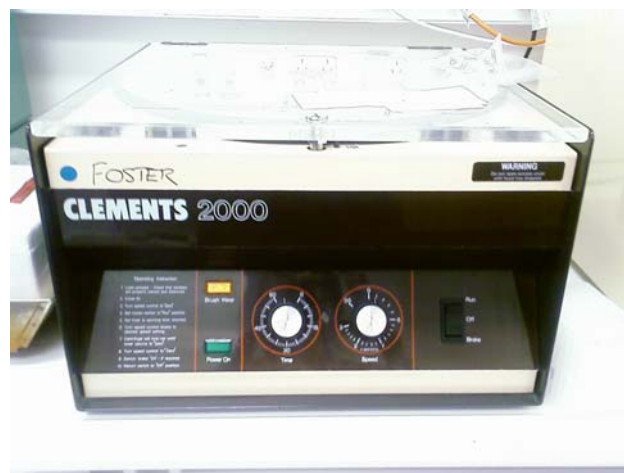
**Figure 1 – Centrifuge**

A recent incident occurred on campus where an older model of bench-top centrifuge (see Figure 1) was discovered to be spinning at a speed that did not correspond to the speed on the dial of the machine.

It was found that the speed marked as '2000 rpm' on the dial at the front of the centrifuge was actually causing the rotor to spin at 3000 rpm.

An adjustment can be made to some centrifuges, which allows changes to the rotor speed. If an adjustment has been made it is possible that the rotor will spin at a higher or lower speed than that marked on the dial at the front of the centrifuge. This is potentially very dangerous.

Older centrifuges (those not under a service contract) should be tested and if not running correctly should be calibrated so that the rotor speed corresponds to the speed on the dial.

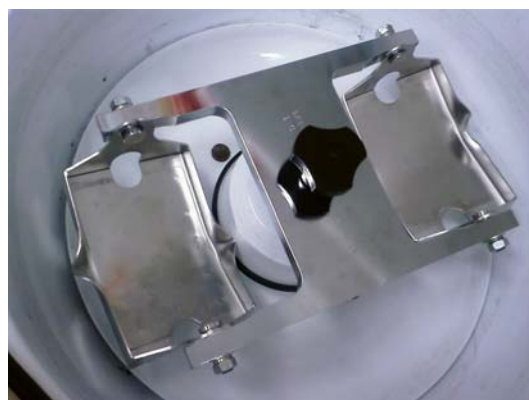
**Figure 2 – Warping of the Rotor**

The centrifuge was being used with a new rotor that had a maximum speed of 2000 rpm. The rotor was spun at a higher speed, which resulted in a warping of the rotor (see Figure 2). Luckily no catastrophic failure of the rotor occurred.
